Test Report No.: SHAEC23007008908 **Date**: Jun 02, 2023 Page 1 of 4

Sample Name: 8200T
Style/Item No.: 8200T
Sample Description: Adhesive

Halogen

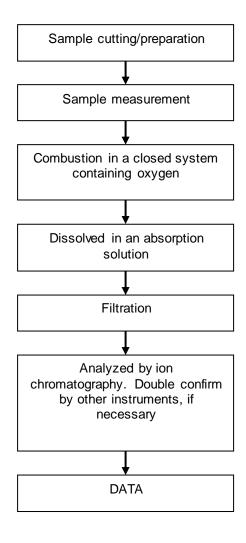
Halogen Testing Flow Chart

Test Method: With reference to EN 14582:2016, analysis was performed by IC.

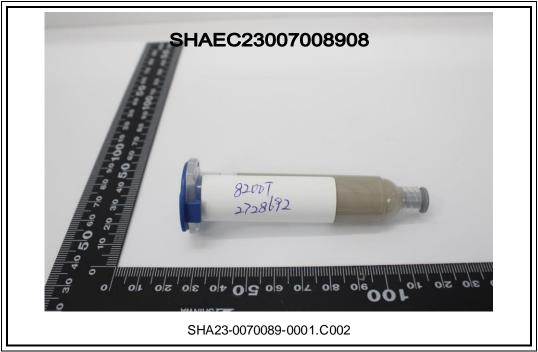
Sample Photo:

SN ID	Sample No.	SGS Sample ID	Description
SN1	A2	SHA23-0070089-0001.C002	Gray paste
